# Atalanta Restoration Plan

Prepared by Gavin Pascoe

May 2014

This document should be read in conjunction with Bruce Askew's survey report and drawings.

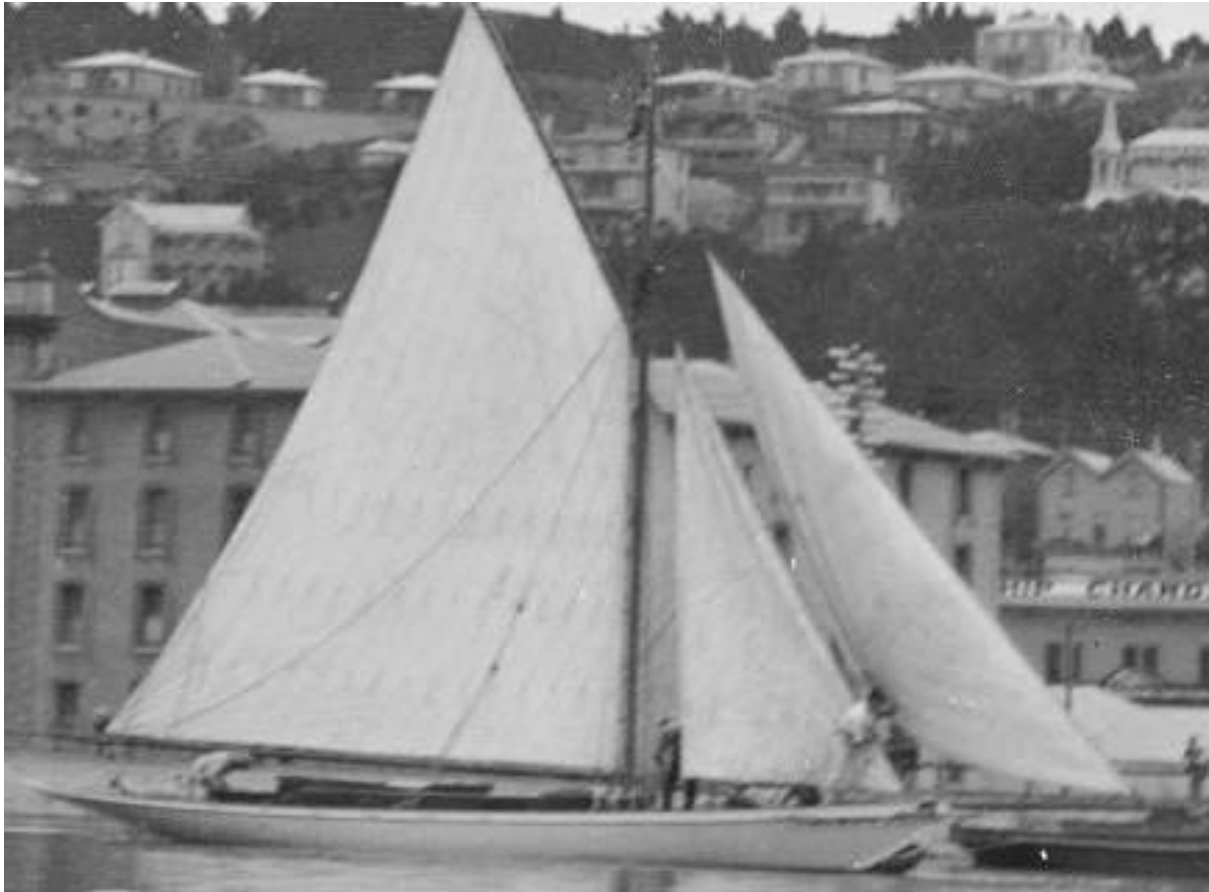
The image below is taken in Wellington. It is dated ca. 1895 by the Alexander Turnbull Library. In 2011 she was identified as *Atalanta* by Harold Kidd. If the dating is accurate (and there is no reason to think it isn't), this is how she appeared upon her first arrival to Wellington. Evident are the low cabin, trailboards and carved fiddle bow

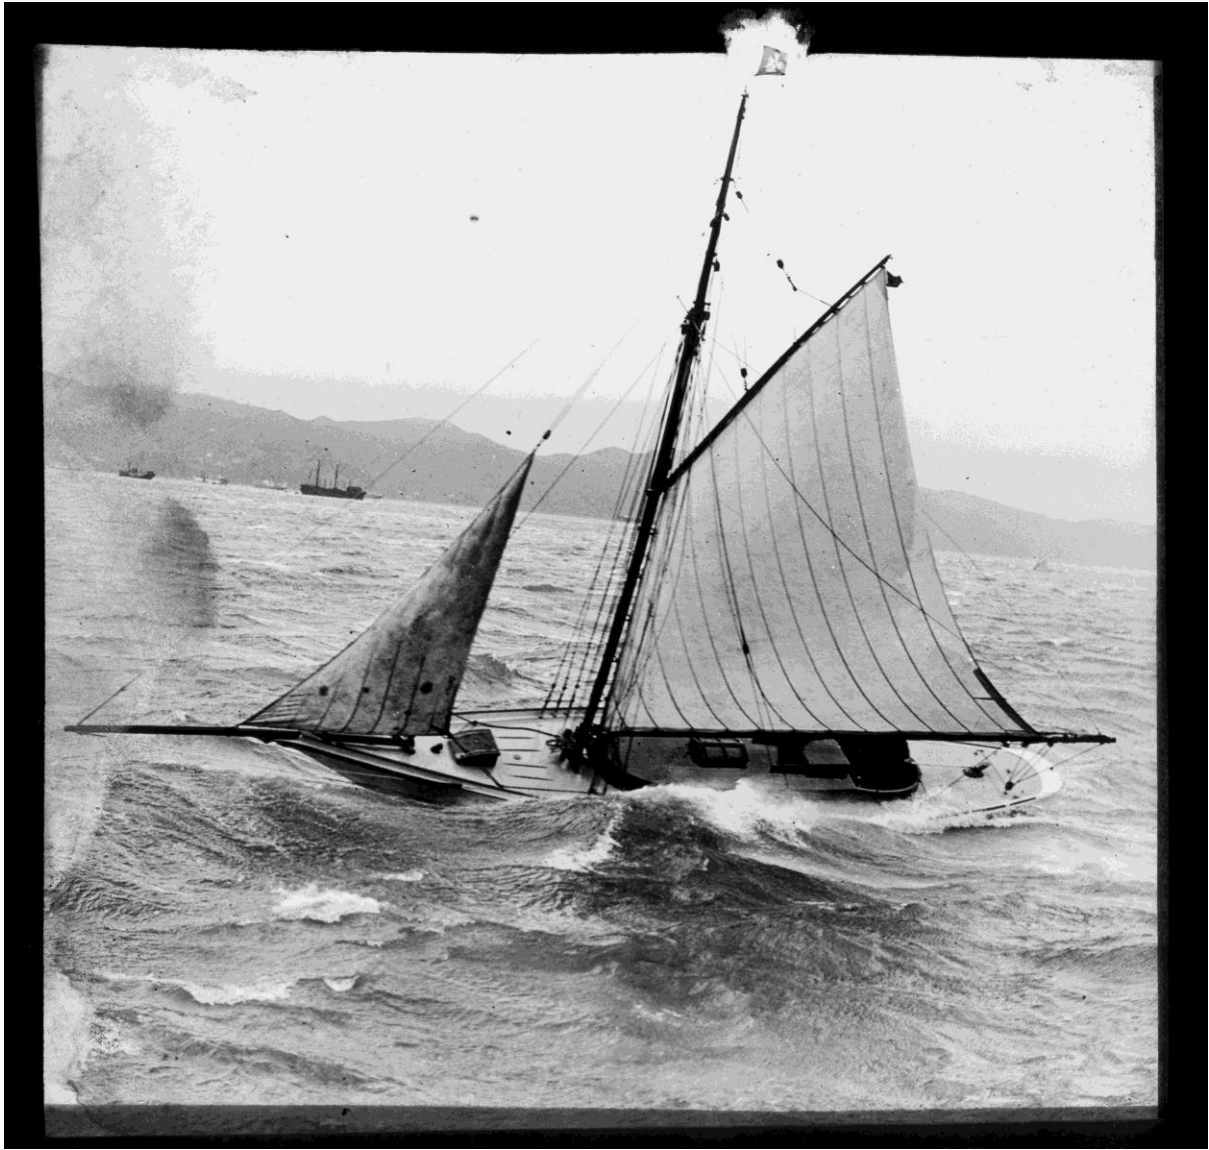
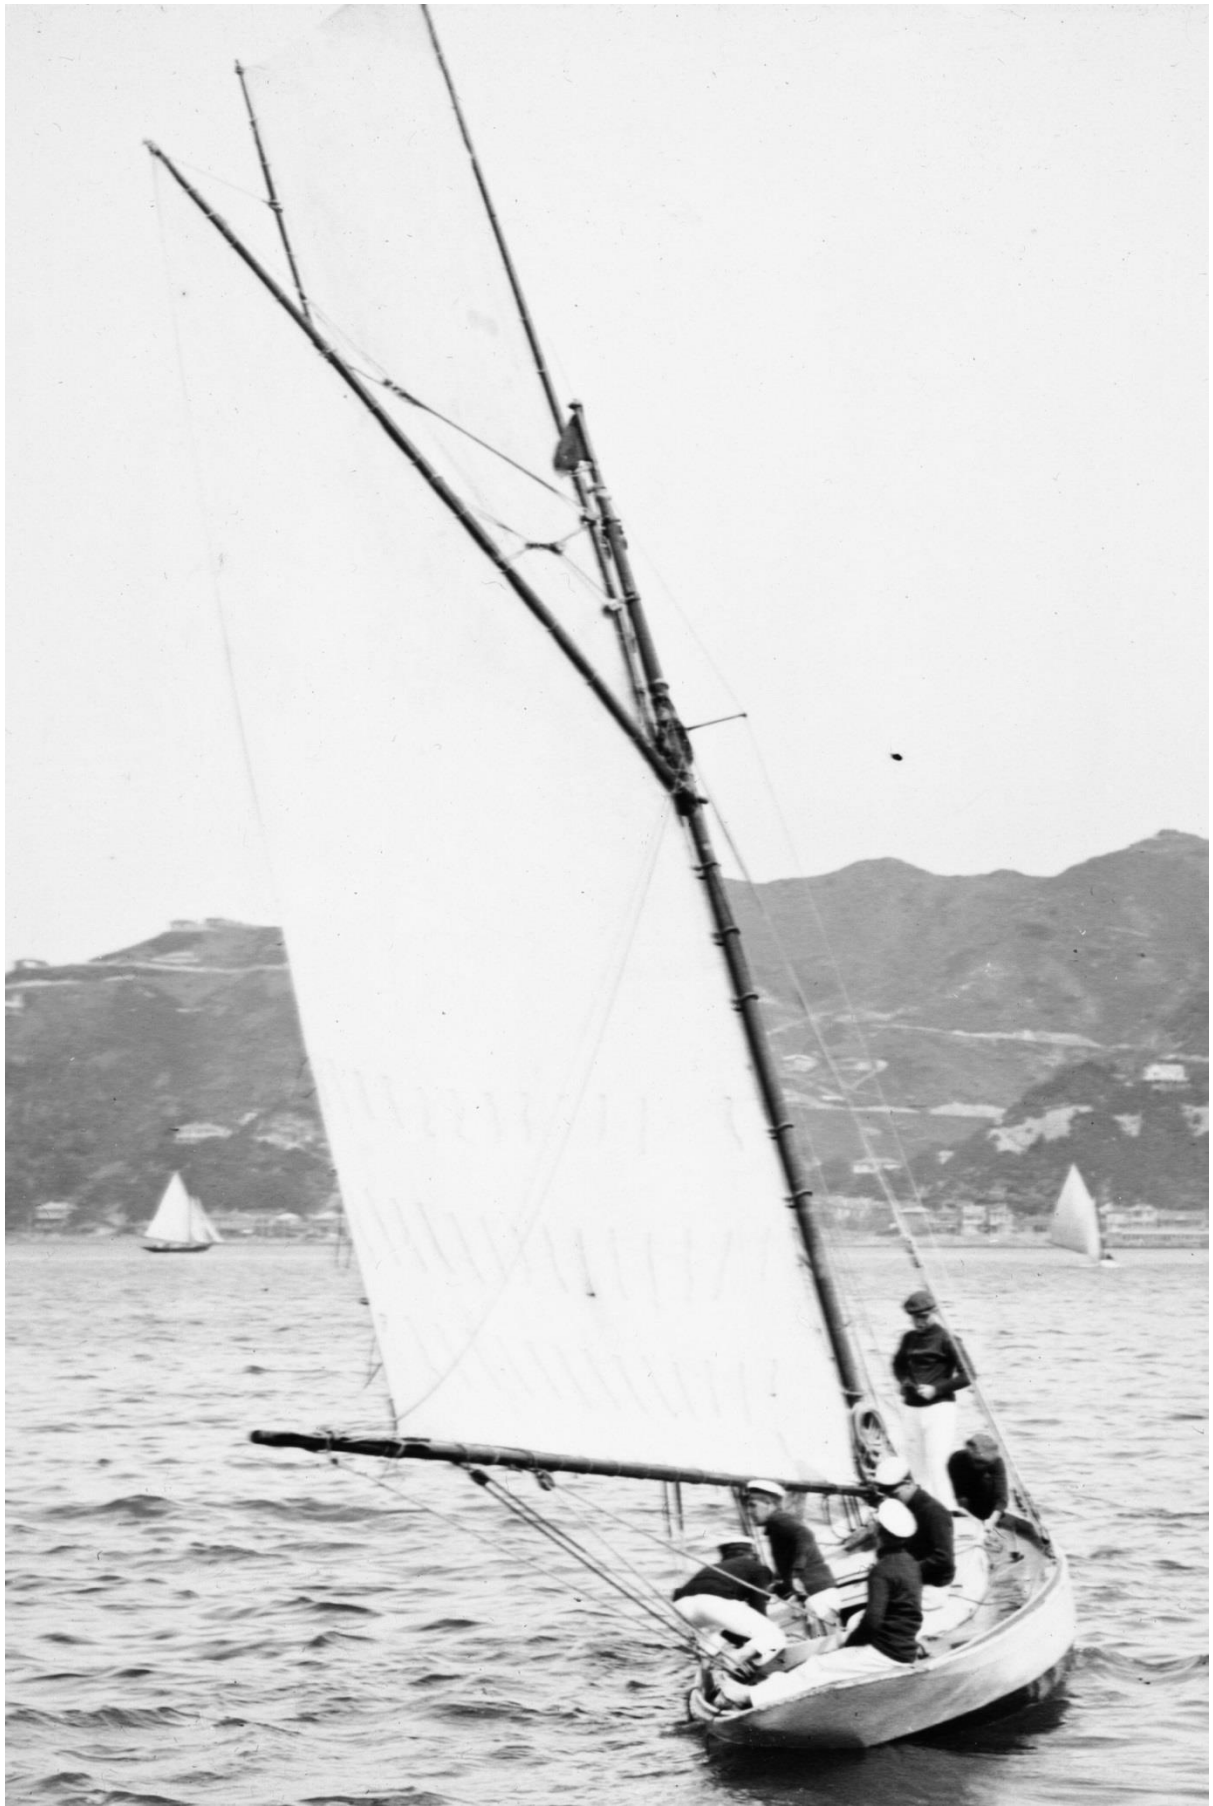
Museum of Wellington City and Sea

These two images are part of a set of lantern slides. They are undated, and the provenance unknown. Taking into consideration the subjects of the other slides in the collection, they are most likely to date to between 1909-1914.

Apparent in these photographs are the battens on the foredeck to aid crewmen's balance; internal chainplates, club-footed topsail, iron tiller, chain pipe and scoop forehatch. The coamings have been painted white in the second image.

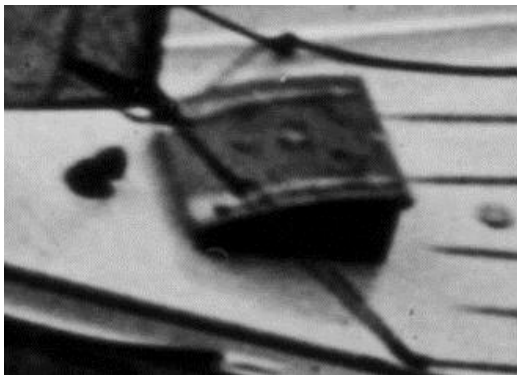
Hatch, battens, and bowsprit shroud detail

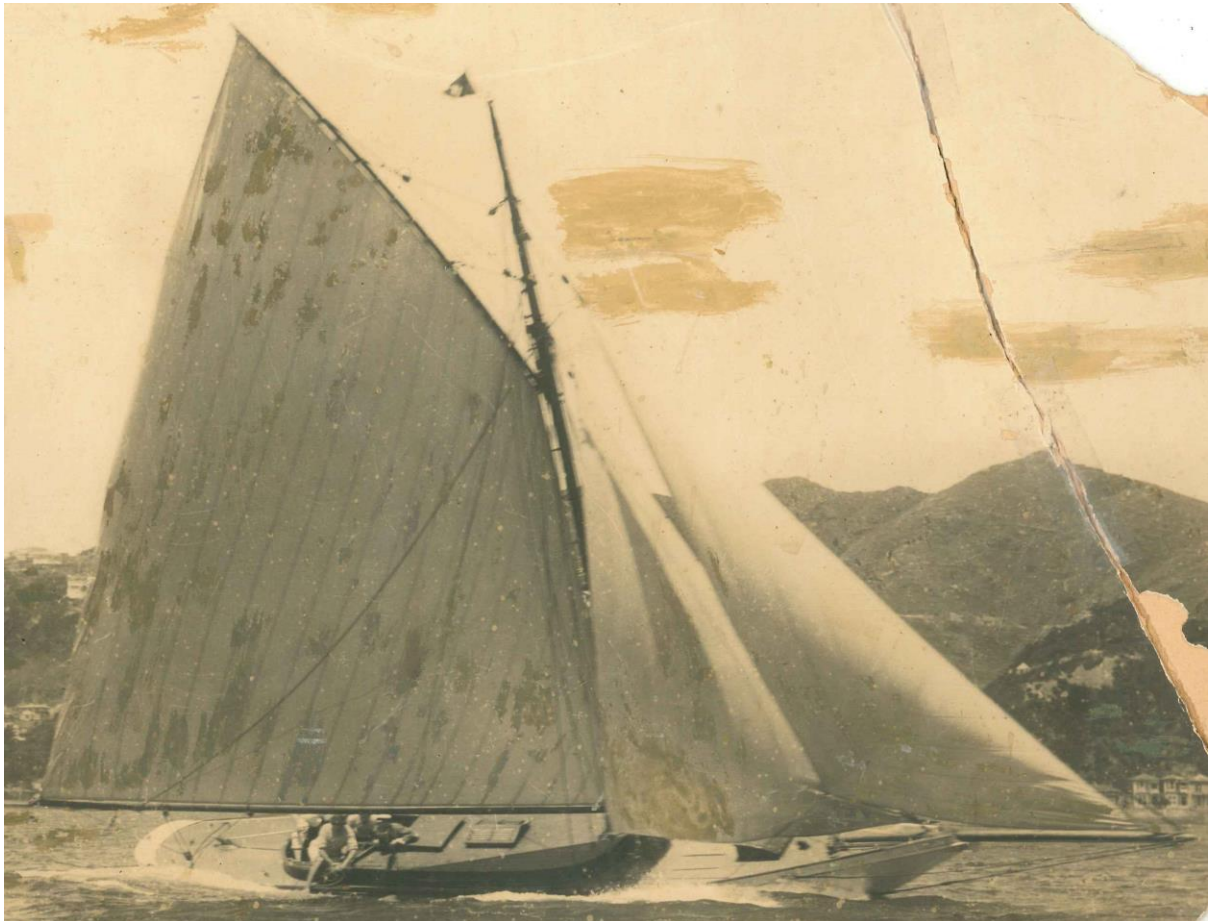
Royal Port Nicholson Yacht Club

This photograph was taken during the 1920s. She appears little changed from the images in the Museum of Wellington City and Sea collection. The trailboards are removed, and a floral design painted on the toerail.

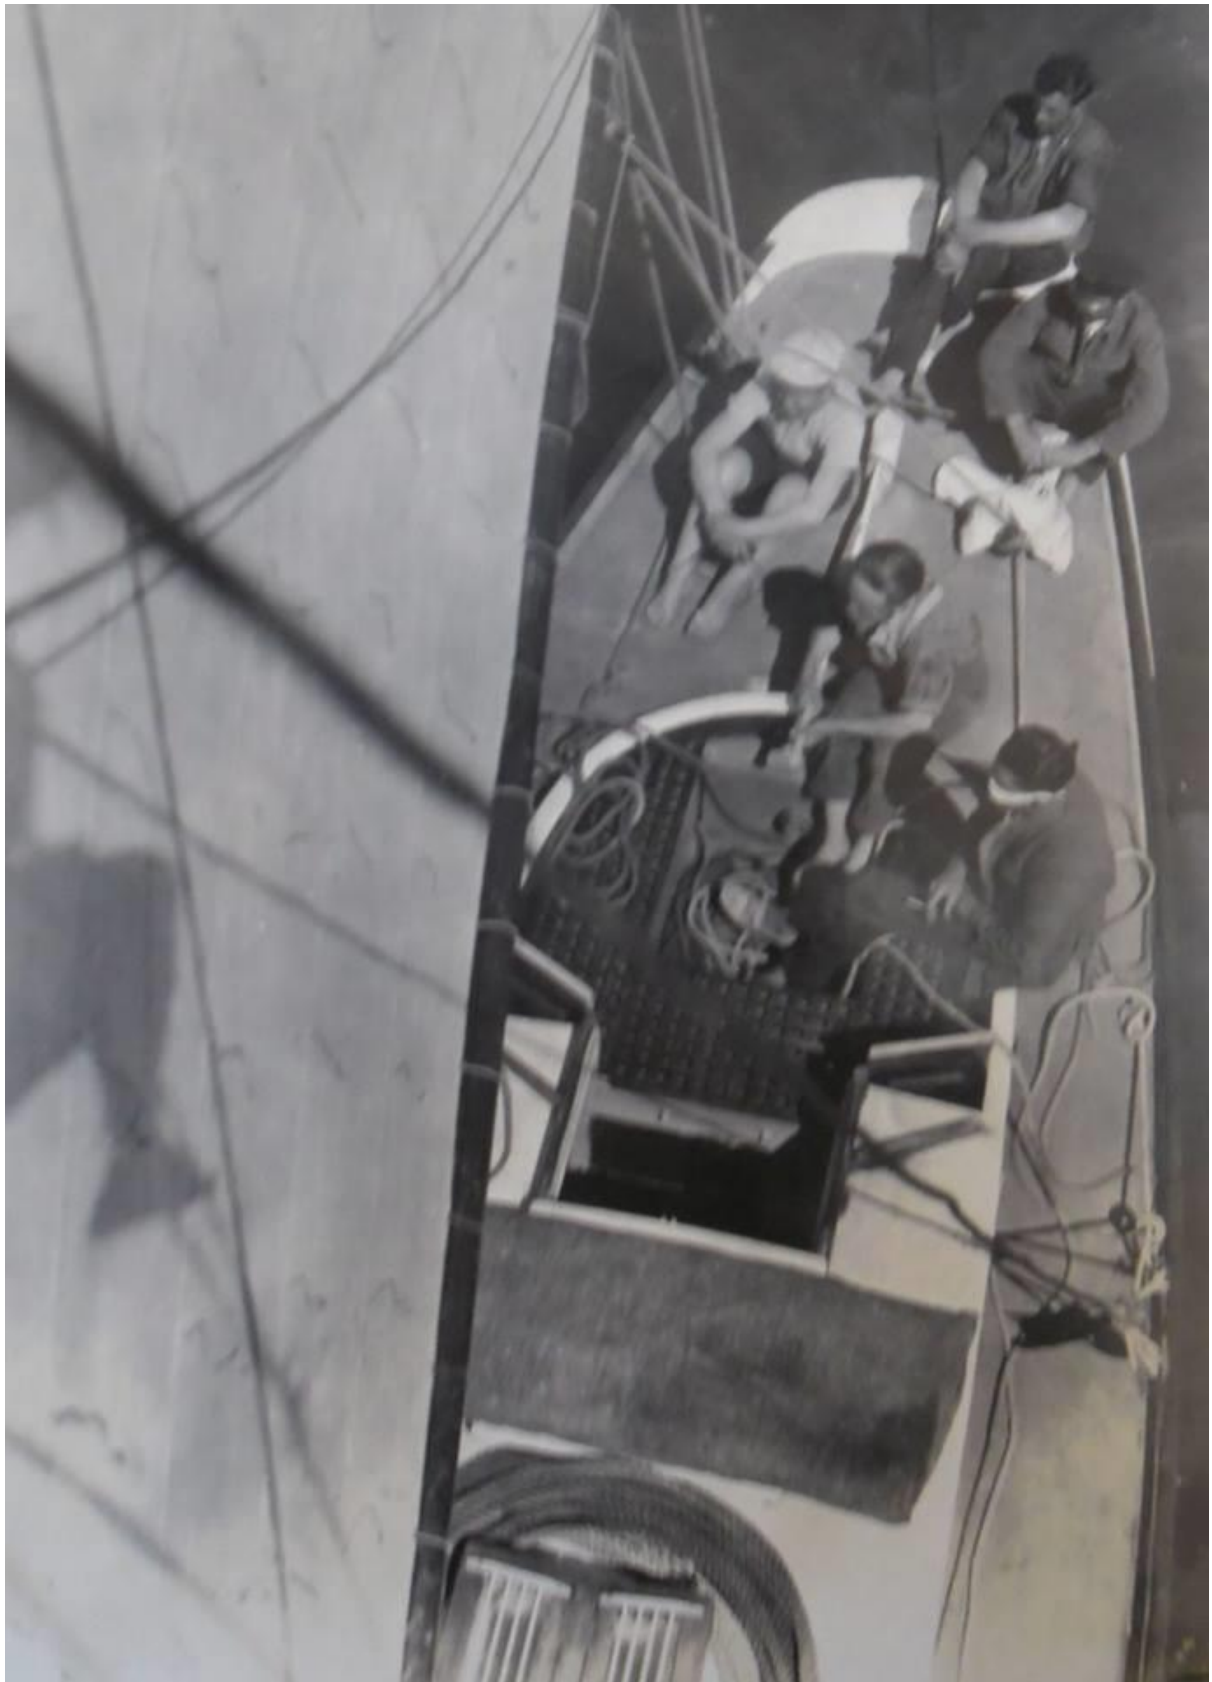
W. M. Moffat

This photo was taken during the 1920s. The deck is canvassed (as it likely was originally), the sheeting arrangements of the mainsheet and running backstays is also readily discerned. The cockpit is very open with a large grating. Some design elements of the butterfly hatch are evident.

Comparing this image with the second of WMCS, the joinery of the toerail and blocking on the transom may be deduced.

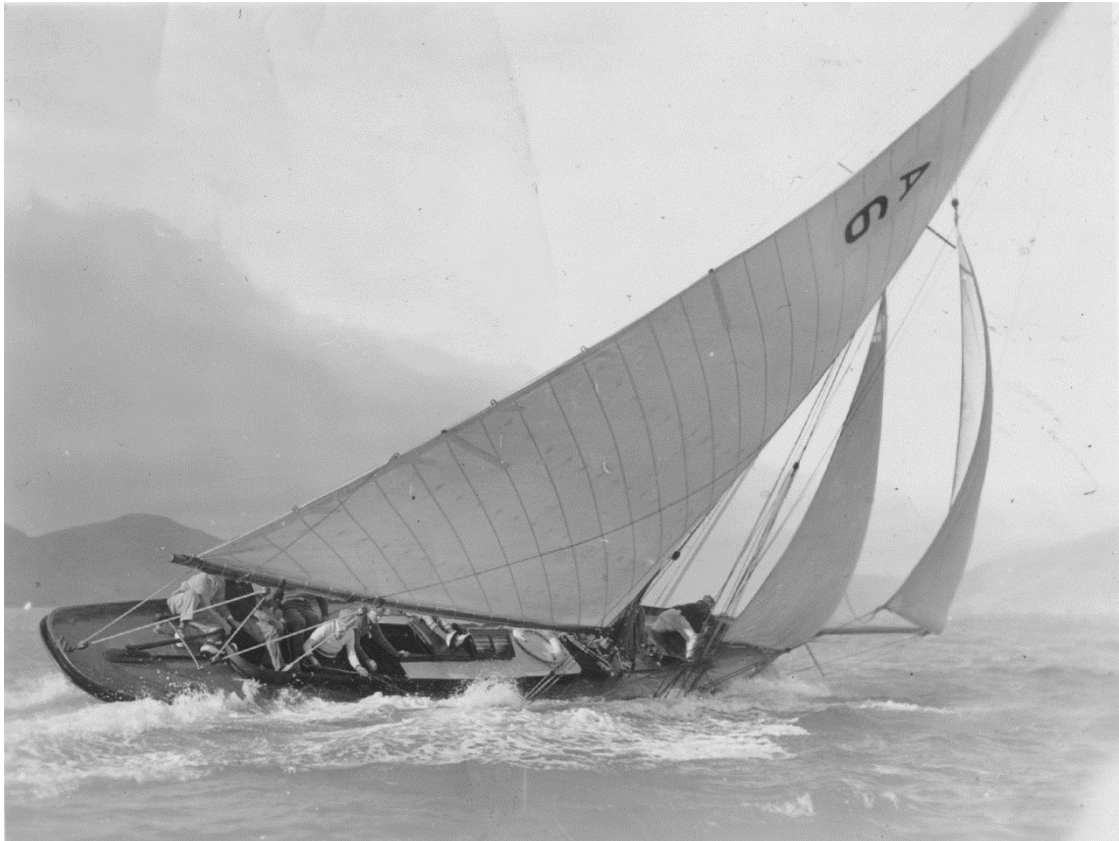
Harold Kidd identifies this vessel as *Atalanta* sailing during the 1930s. She has undergone some significant changes. Her cabin and cockpit have been rebuilt; the cabin is shorter, and has squarer ends forward. The cockpit is longer. The transom block has also changed shape, with the rails running full around the counter. The tiller is now timber, and extends below the mainsheet horse, which has been moved forward. She also appears to have either a dolphin striker or spreaders on the bowsprit shrouds.

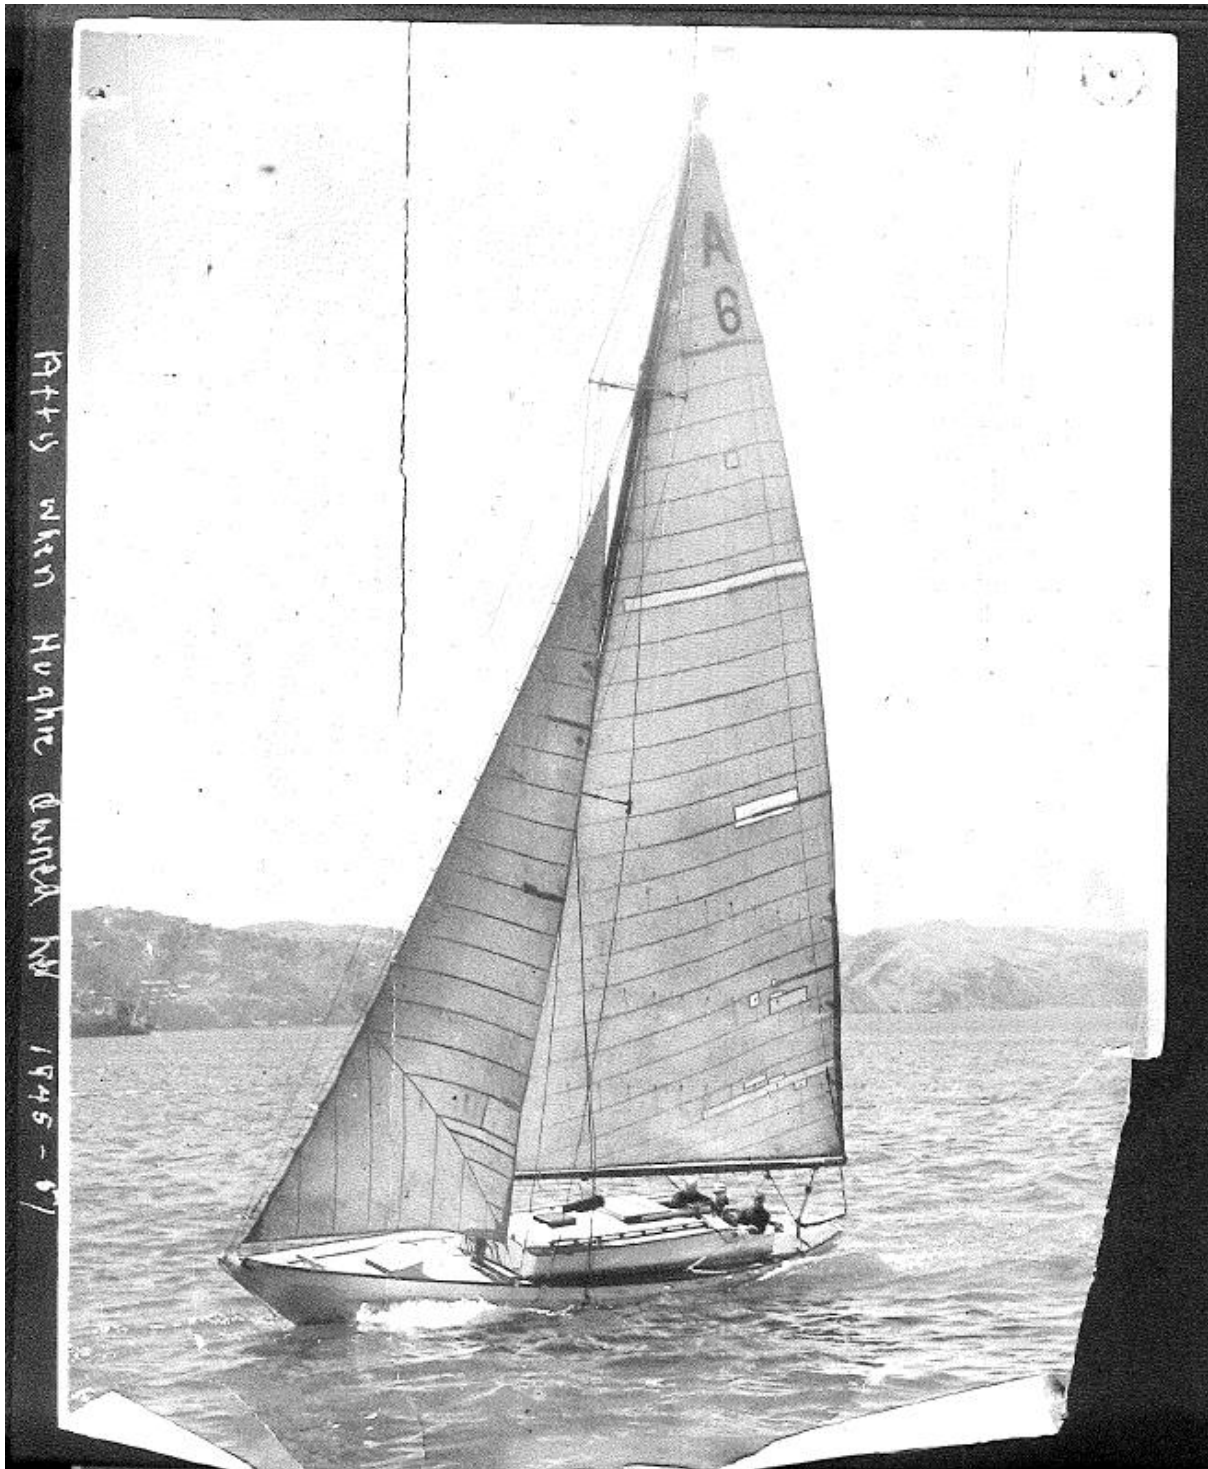
The first image below shows *Atalanta* in her most dramatic change – converted to a Bermudan sloop under Cliff Cunningham's ownership. Her cockpit and cabin top have been rebuilt with square ends and no ports. Her counter is shortened and fiddle bow removed, changing the profile of the stem. Her sheerline has been changed forward, accented by a new toerail: flared and very full at the bow, with a pronounced taper running aft. It is likely this is when *Atalanta* was converted from a centreboarder to a keeler. She had definitely been converted by the time Hugh Askew purchased her. The second image was taken during Hugh Askew's ownership. She has a new taller mast, and her keel has been deepened.

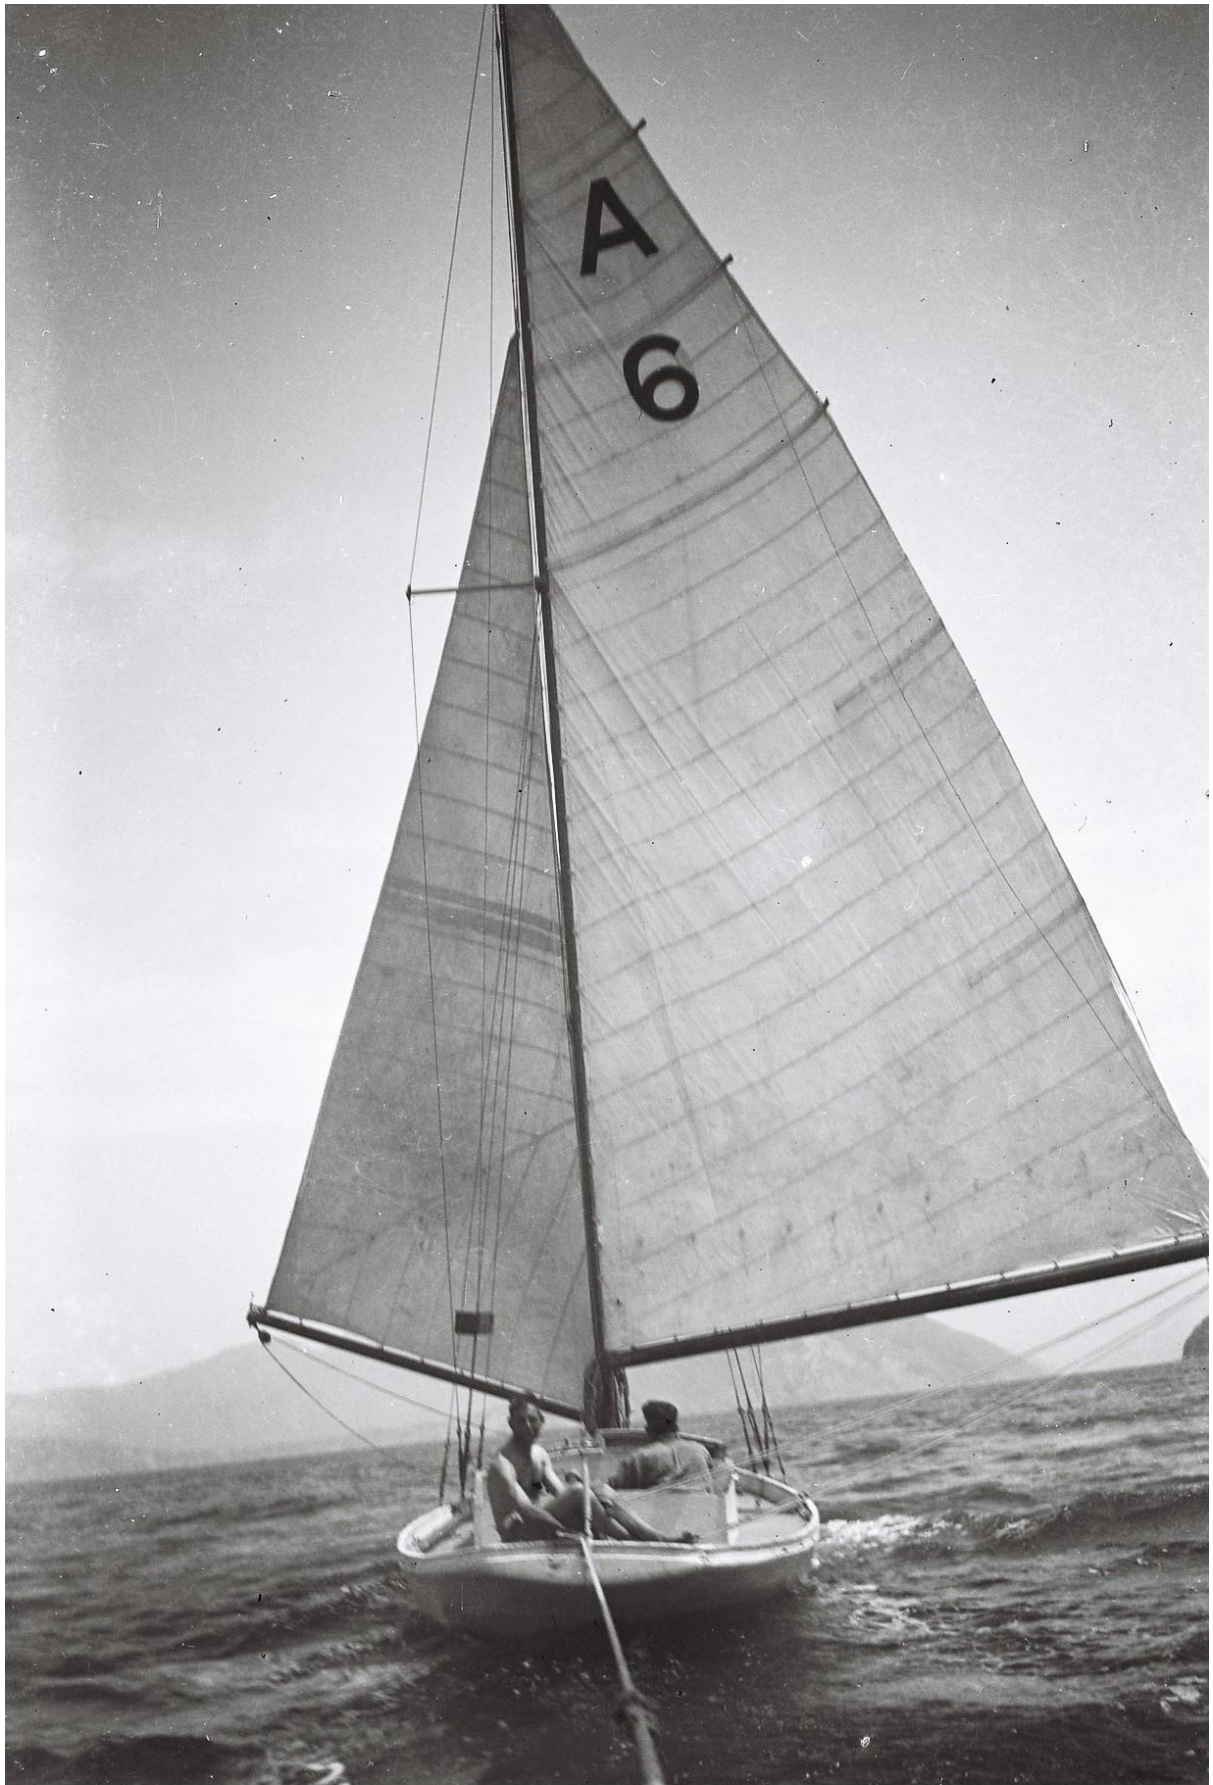
David Fisher

This image taken during the late 1930s when in Cunningham's ownership shows the twist in *Atalanta's* transom. It has not worsened in the intervening time.

She has a slight twist in the aft section of her hull, which according to photographic evidence has been there at least from the late 1930s. This is common to boats of this age and construction, and does not impact upon the safety of the boat. The twist appears to be confined to the section of the hull aft of the companionway and is only really apparent at the transom.

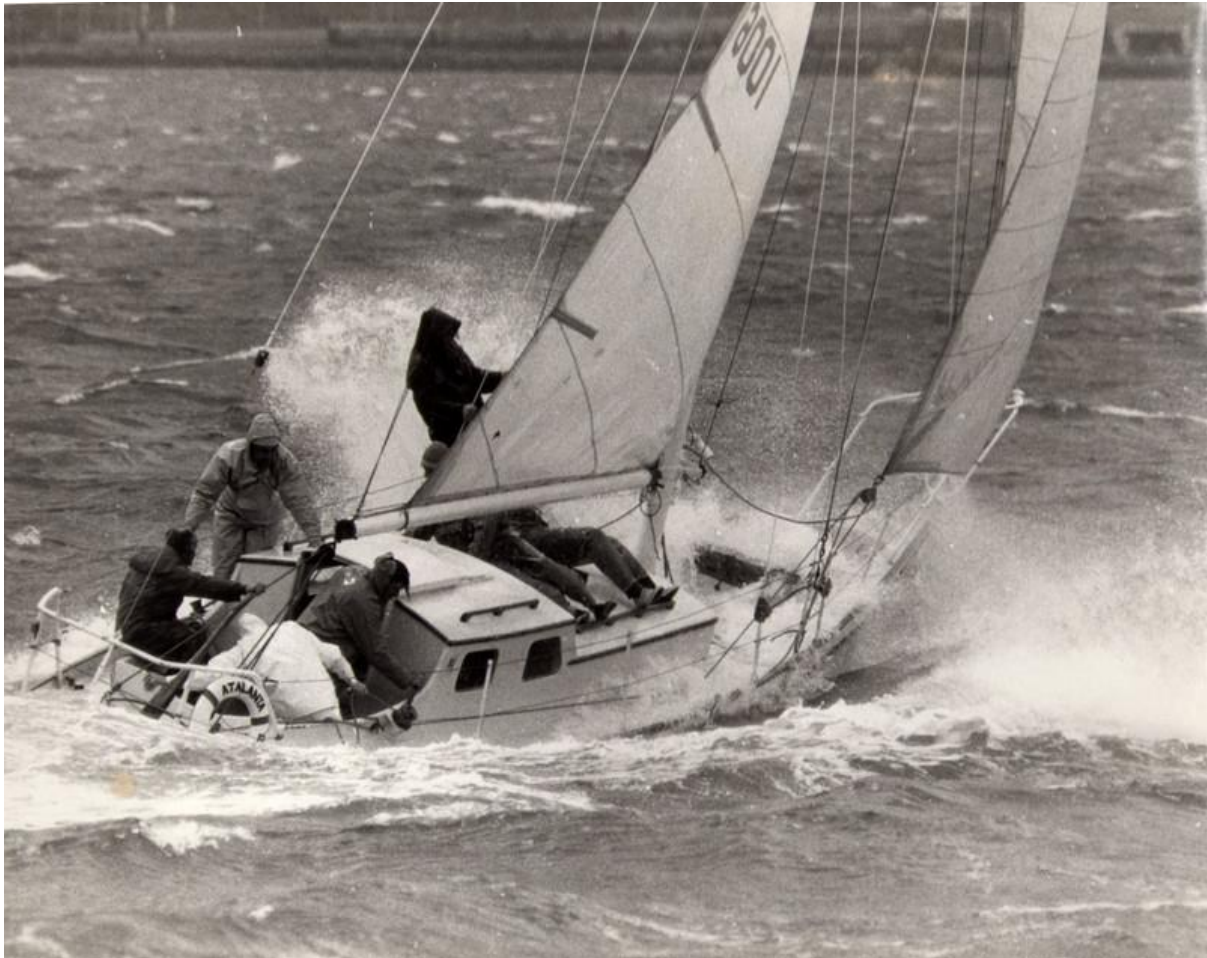
Pat Millar

This image taken during the 1960s or early 1970s shows *Atalanta* in the configuration she had when she came to the Wellington Classic Yacht Trust. Her cabin has been altered, with a raised area to the house, and ports added. Her mast and spars are now aluminium. Since this photo was taken, a ply laminate has been laid over the deck, and the forward hatch rebuilt to a flat profile.
